Final Report

Investigation Into Service Quality Provided By Public Service Company Of New Hampshire Within The Town of Bedford, New Hampshire

For:
**New Hampshire
Public Utilities Commission
Docket No. DE 03-113**

Prepared by
Dufresne-Henry

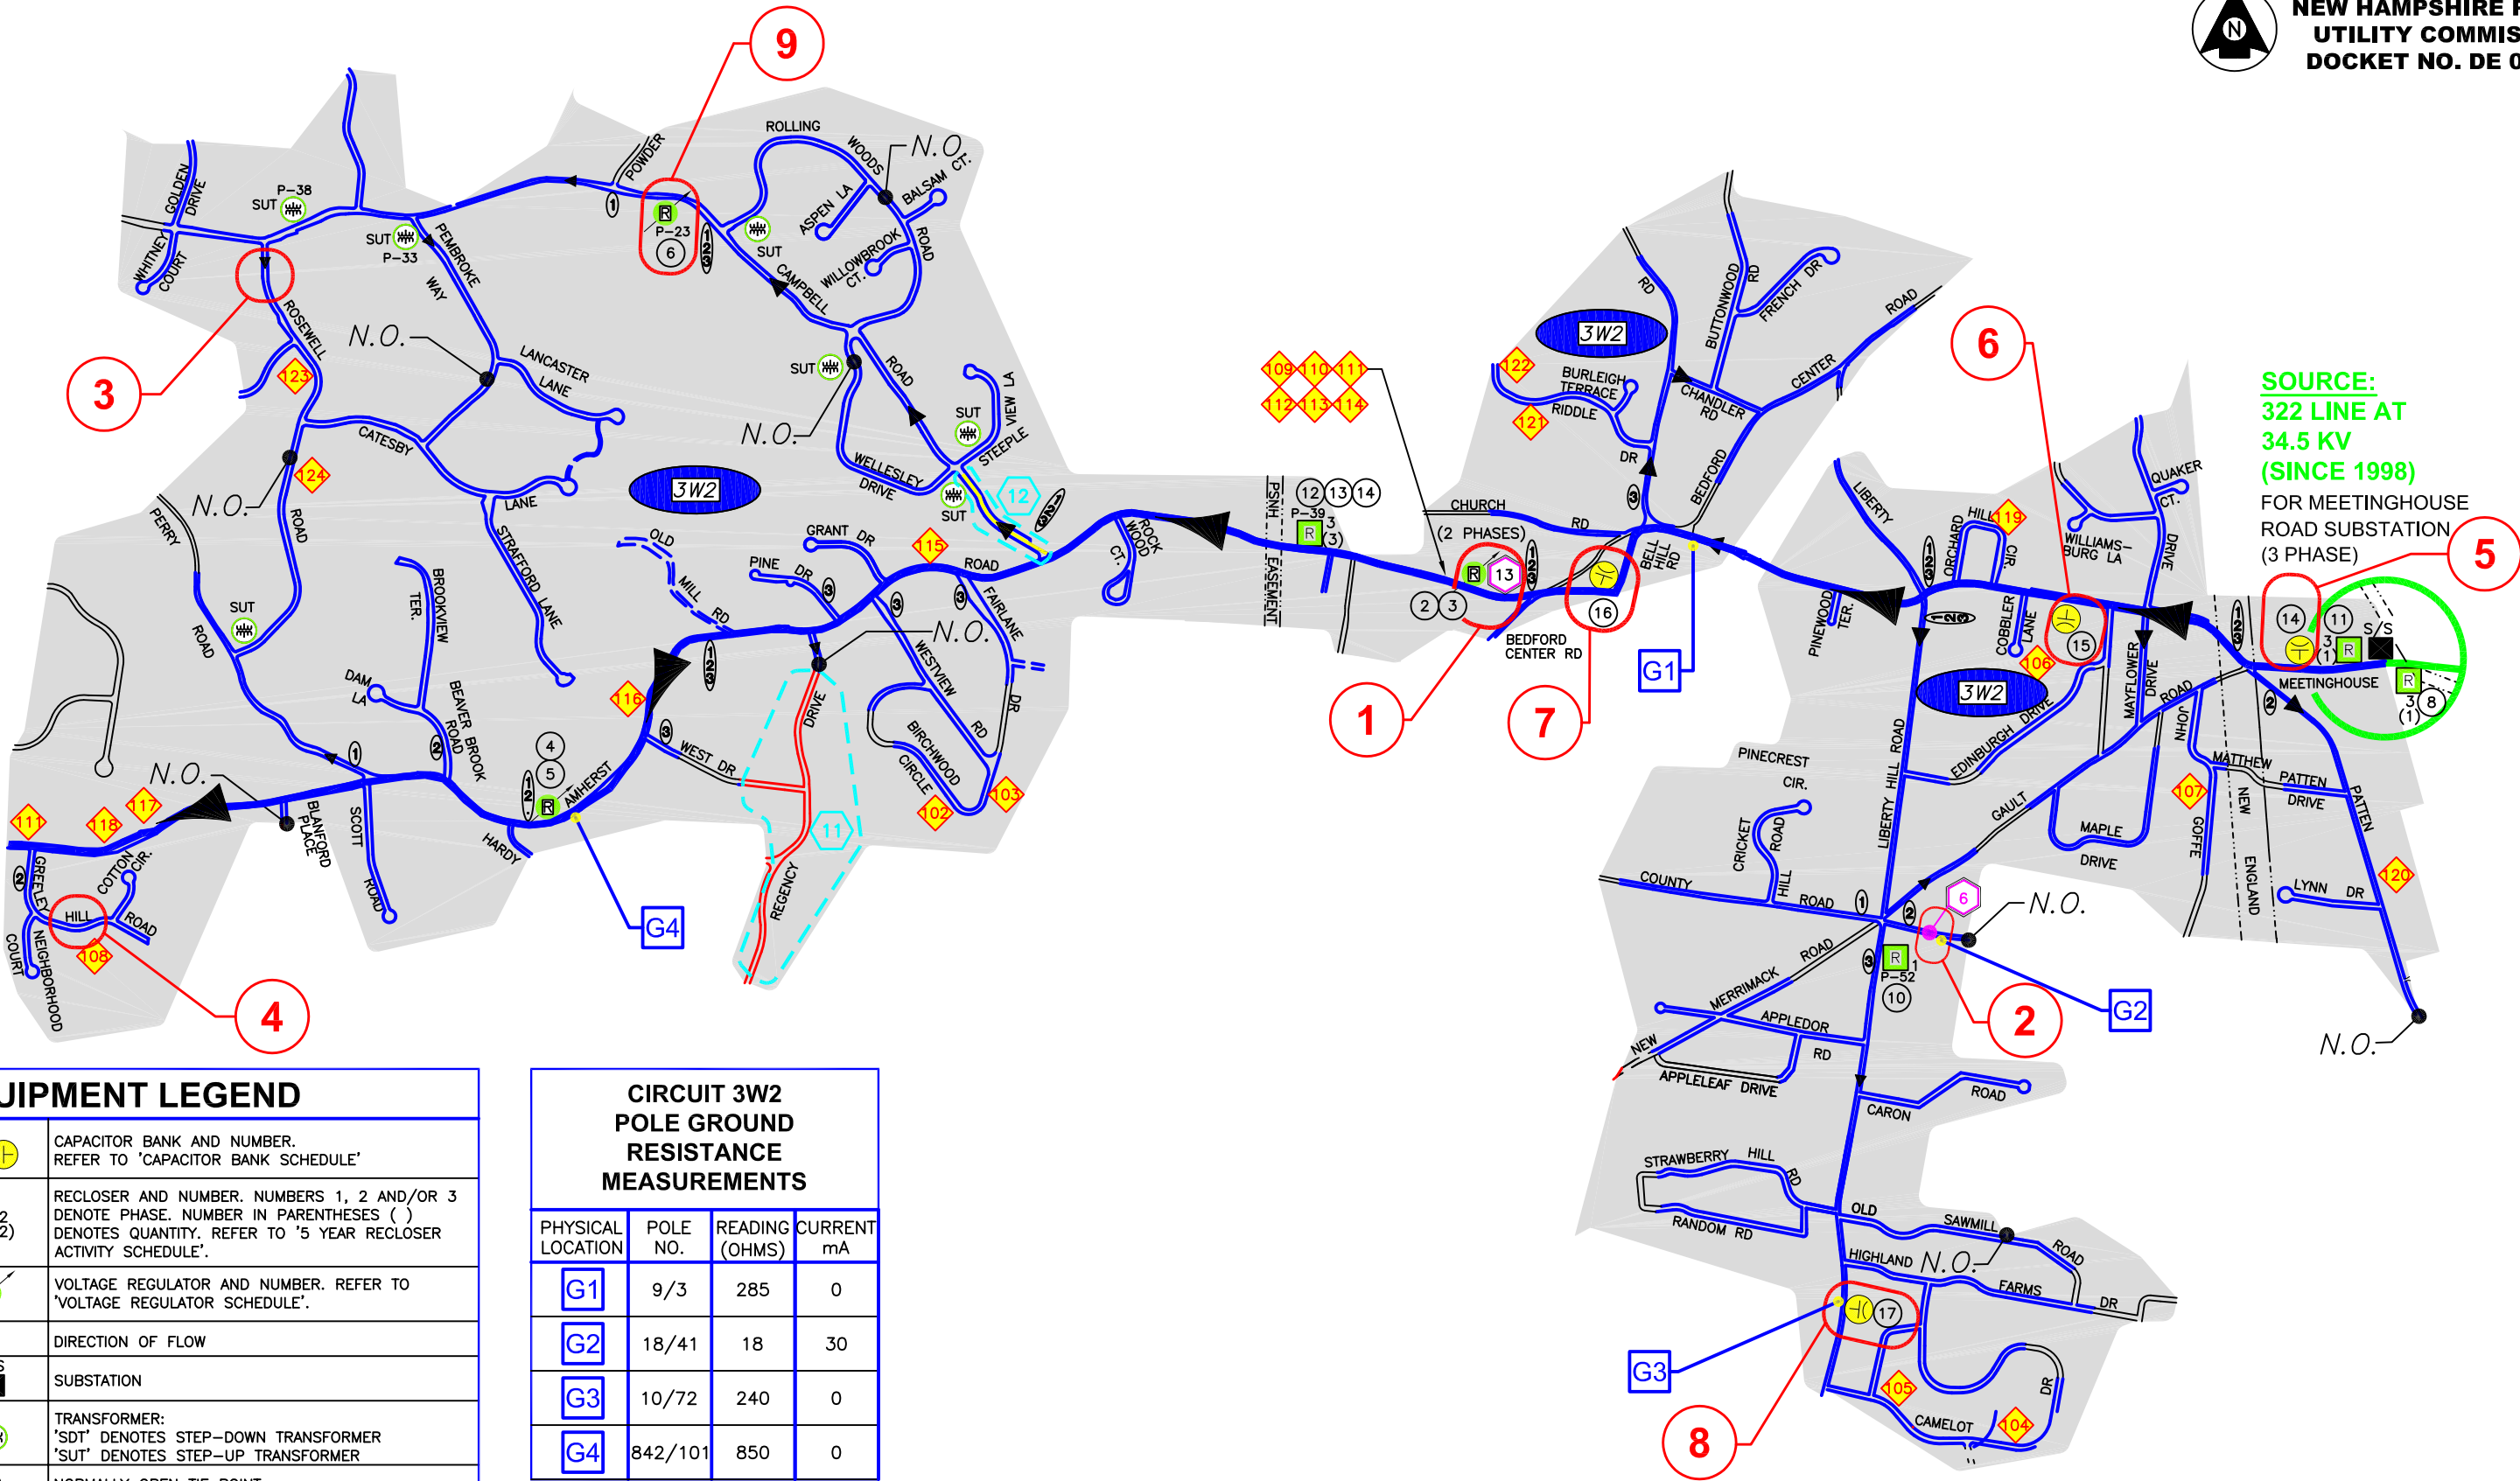
FIGURE 7.1A

CIRCUIT 3W2 POLE GROUND RESISTANCE MEASUREMENTS			
PHYSICAL LOCATION	POLE NO.	READING (OHMS)	CURRENT mA
G1	9/3	285	0
G2	18/41	18	30
G3	10/72	240	0
G4	842/101	850	0

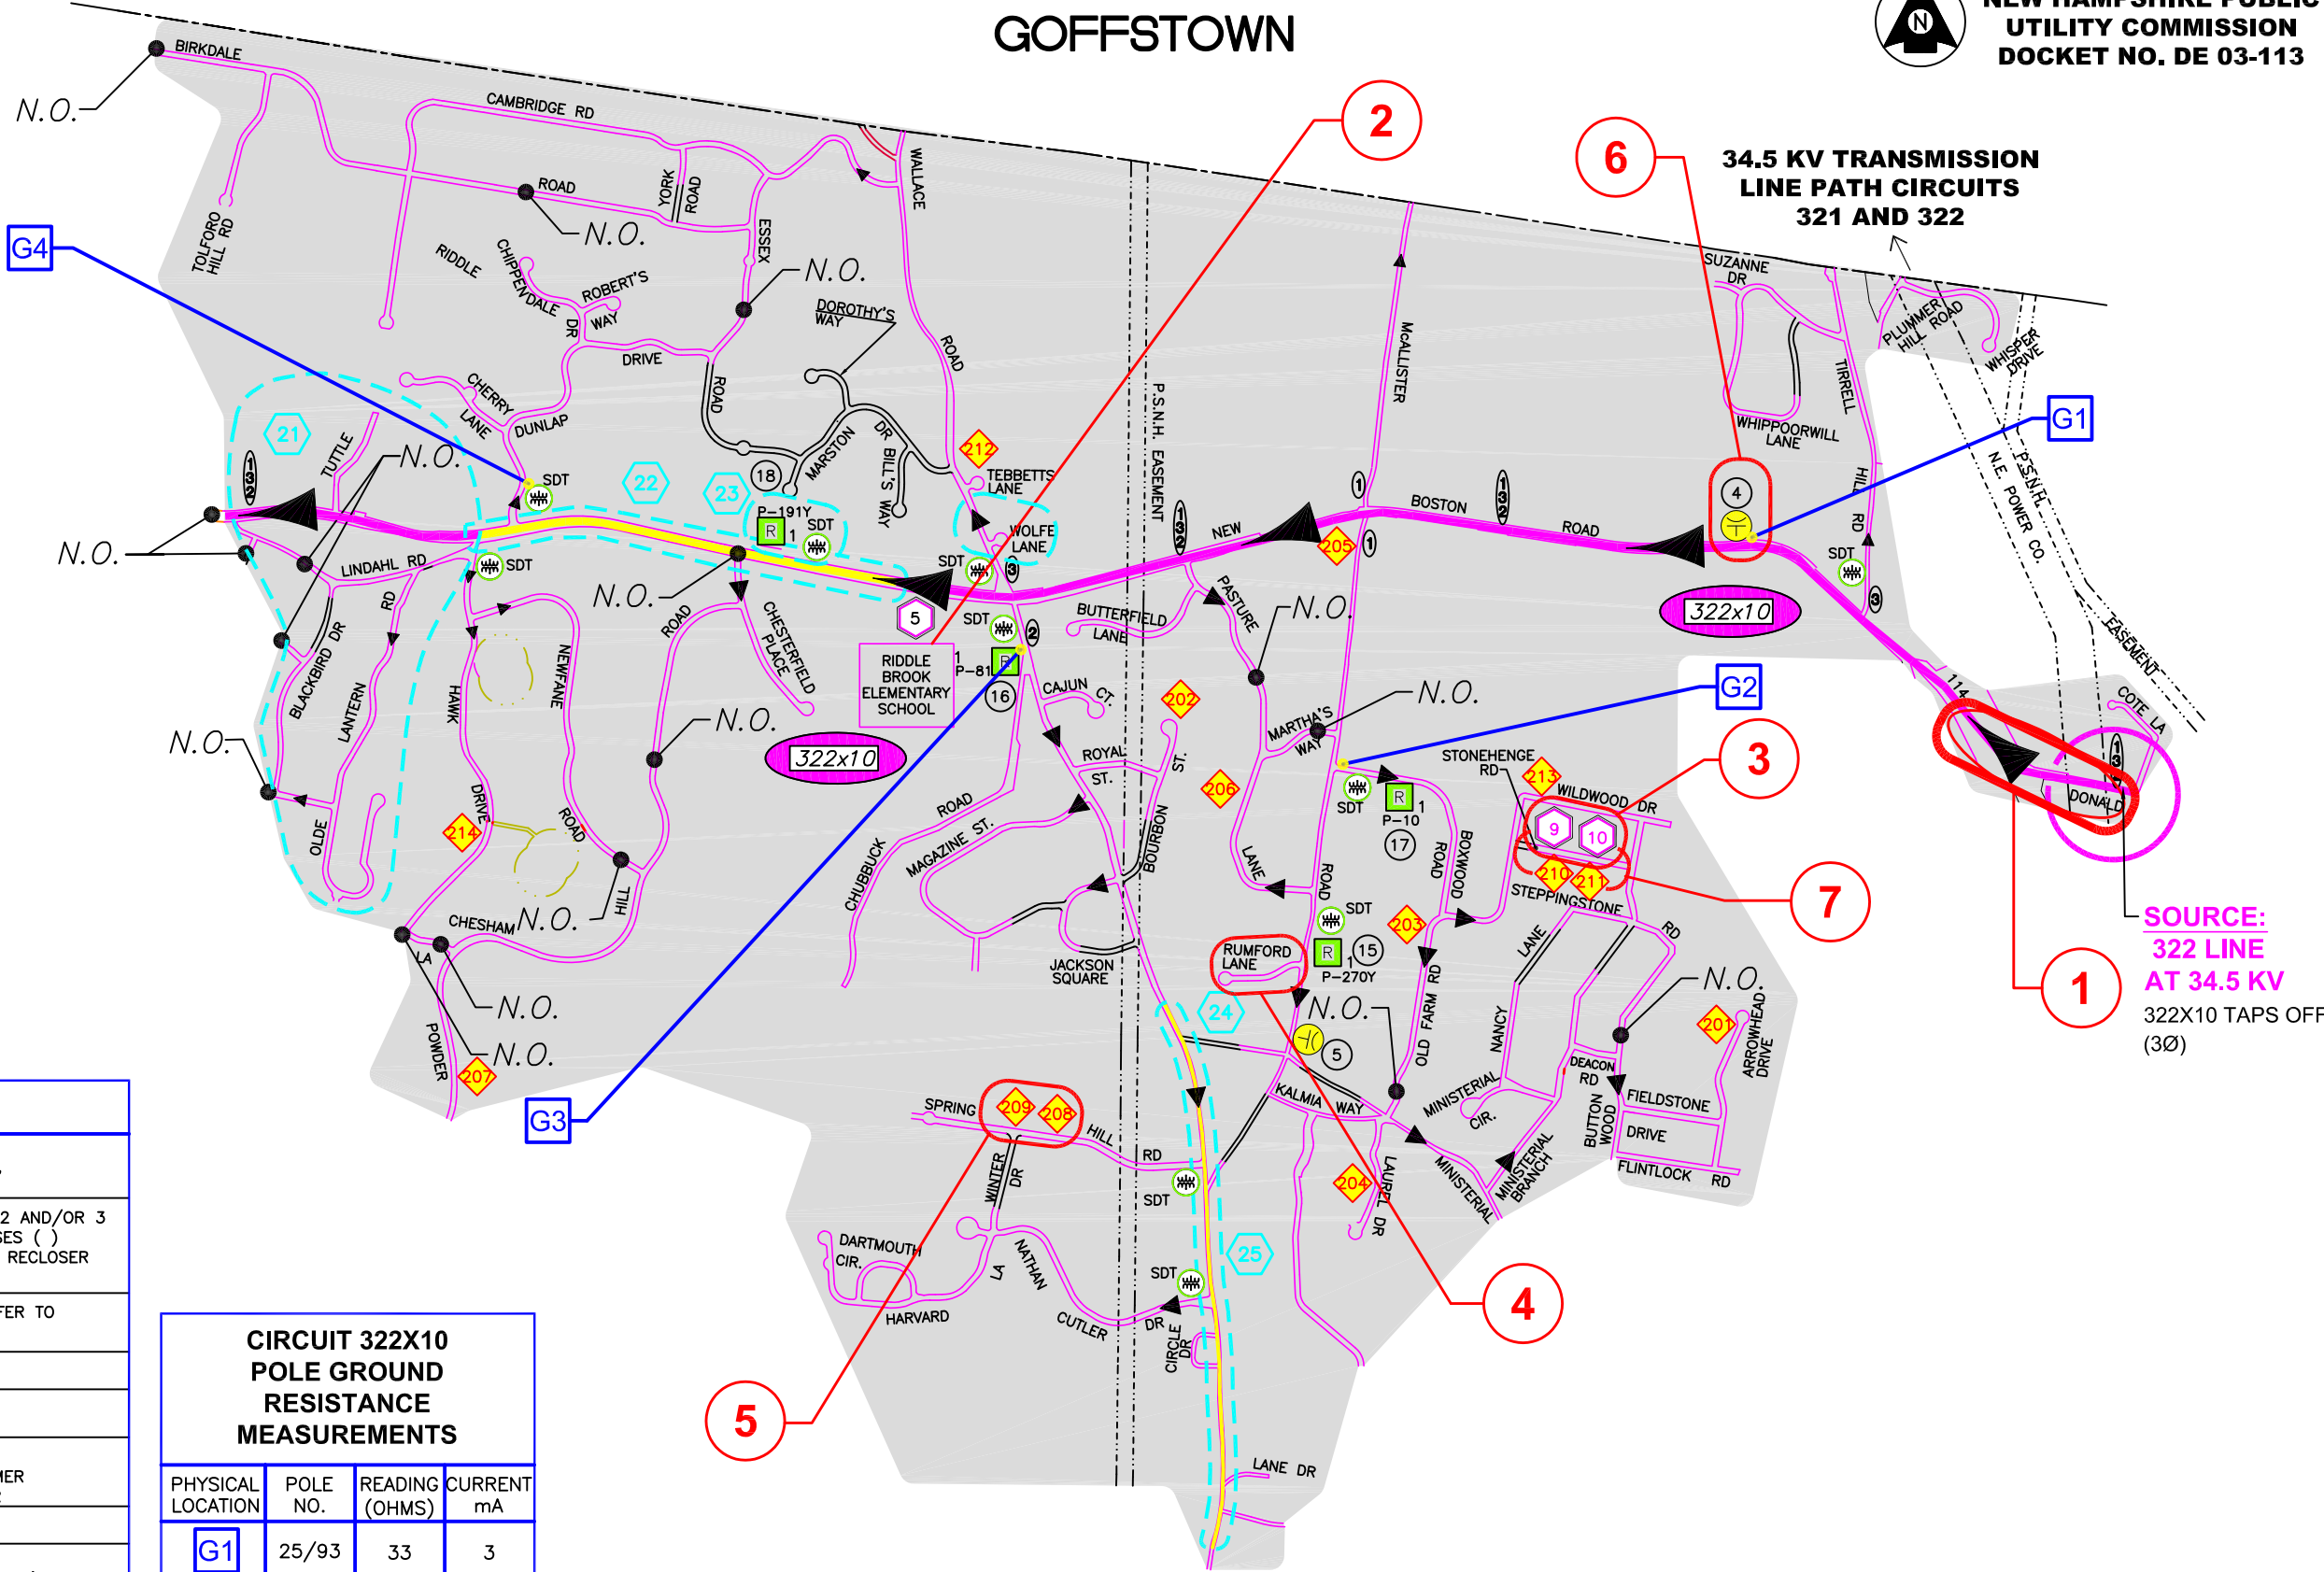
CIRCUIT 322X10 POLE GROUND RESISTANCE MEASUREMENTS			
PHYSICAL LOCATION	POLE NO.	READING (OHMS)	CURRENT mA
G1	25/93	33	3
G2	11/10Y	14	2
G3	2/81	20	0
G4	120/1	24	2

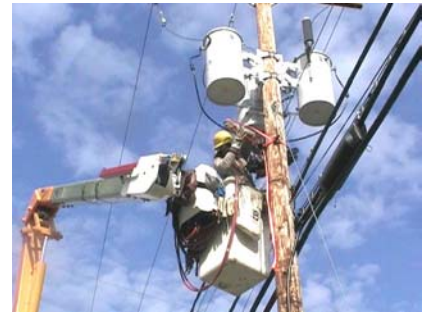
The recorded voltage was found to be on the high side of nominal and the maximum voltage recorded on Phase A was 290.7 volts which exceeded the NHPUC limit by 2.7 volts (0.9 volts on 120 volt base). Upon further analysis, this was found to be a single overvoltage event captured during the entire six day monitoring period as shown on Figure 7.2.1.1.

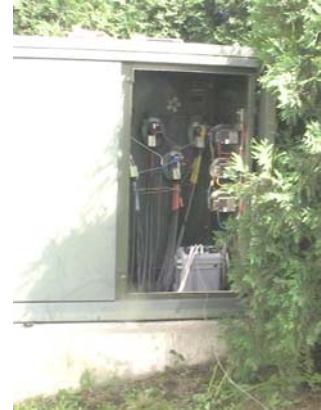
The recorded voltage was found to be on the high side of nominal and the maximum recorded voltage on phase C exceeded the NHPUC limit by almost 1.5 volts and required further analysis.

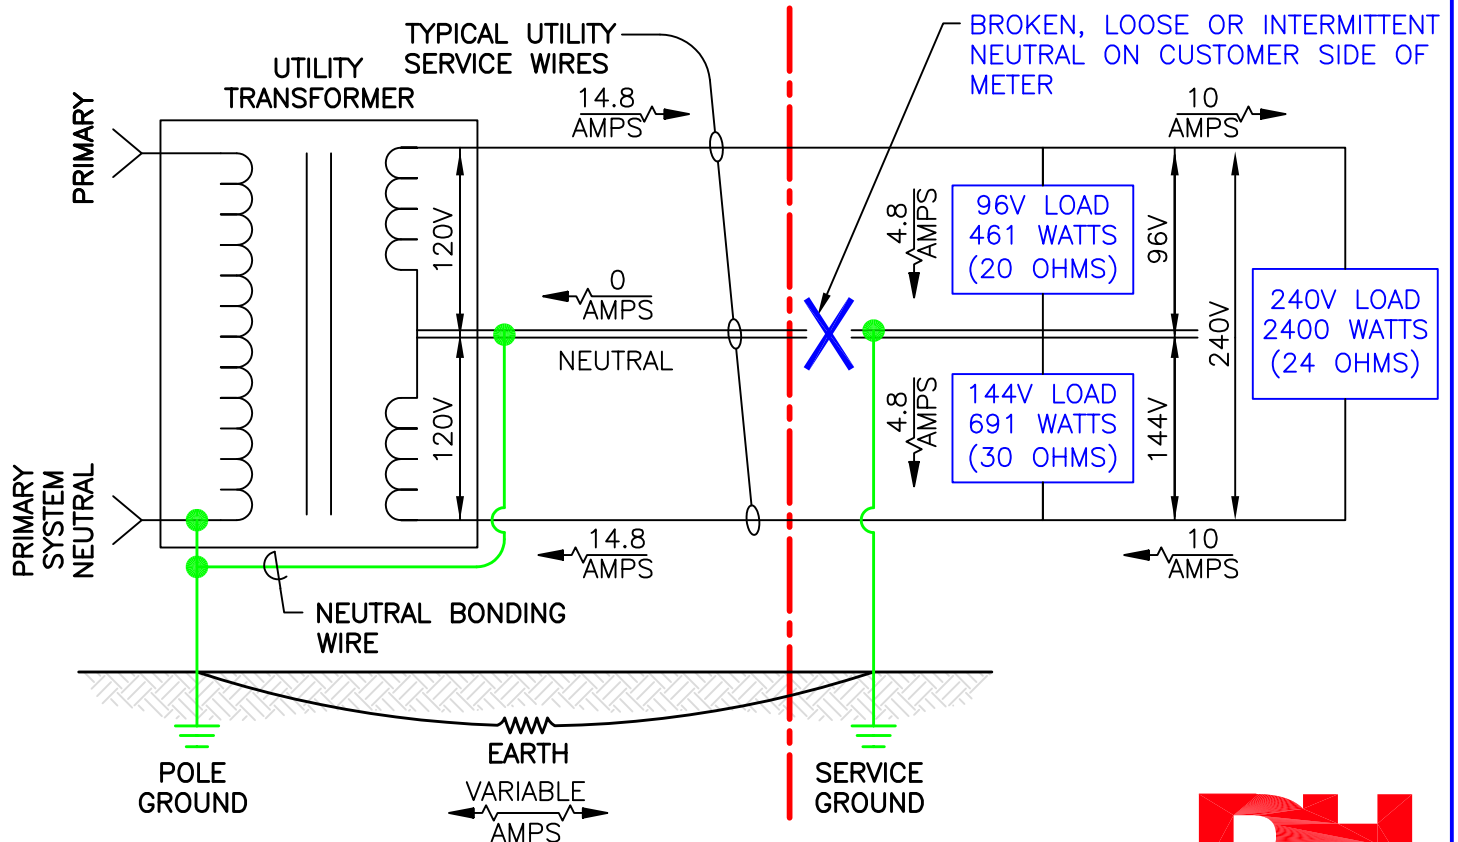
TYPICAL IMPACT ON CUSTOMER'S VOLTAGE CAUSED BY BROKEN OR LOOSE NEUTRAL

Figure 4 of Appendix A contains two sketches of a typical residential service with the first showing the correct installation of the neutral and ground conductors. This simplistic example demonstrates one type of problem that could result from a broken or loose neutral
